TECHNICAL INFORMATION #940

Re: Improvement modification of the IC-2720H/2725E

Model: IC-2720H/2725E (All versions)

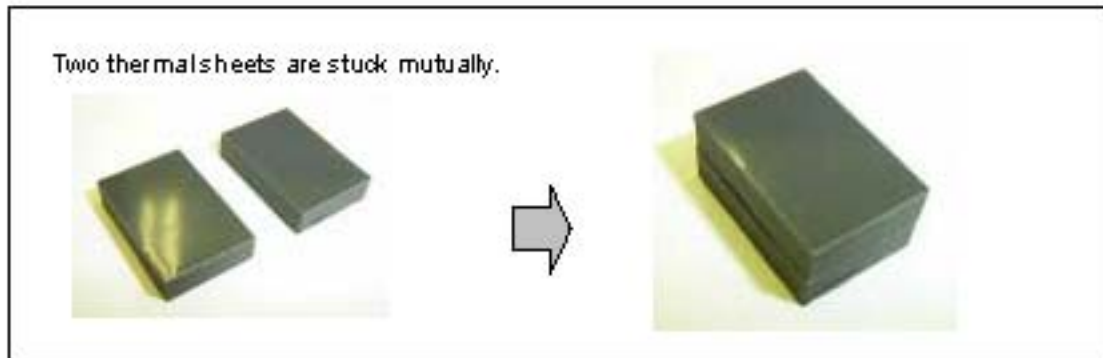
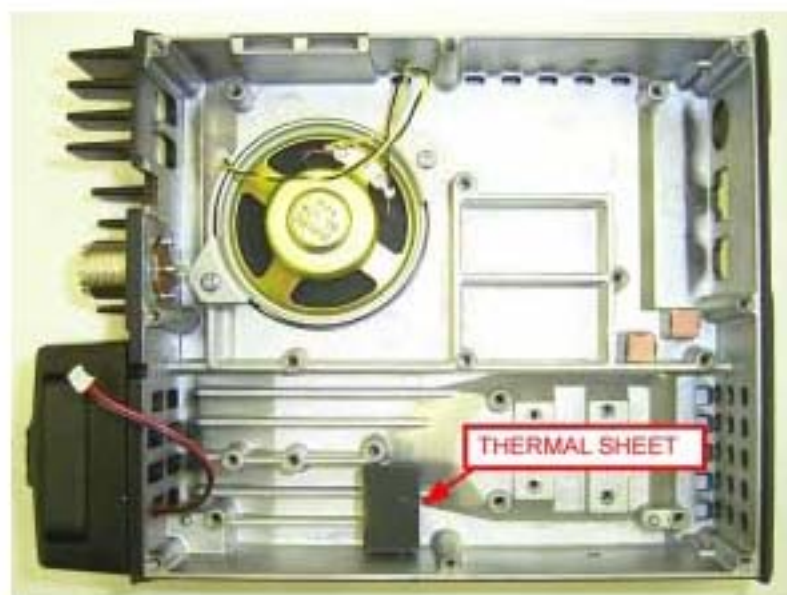
(1) Attachment of thermal sheets.

Around the VHF antenna filter parts on the main board will be damaged when transceiver is using in high temperature environment.

The antenna switch diodes have over heated. It is caused by resistance of the forward direction of the antenna switch diodes are out of specification.

Put thermal sheets to the CHASSIS as shown below.
